MARINE EXPOSURE TESTS ON STAINLESS STEEL SHEET

By Willard Mutchler

National Bureau of Standards

Washington
February 1947

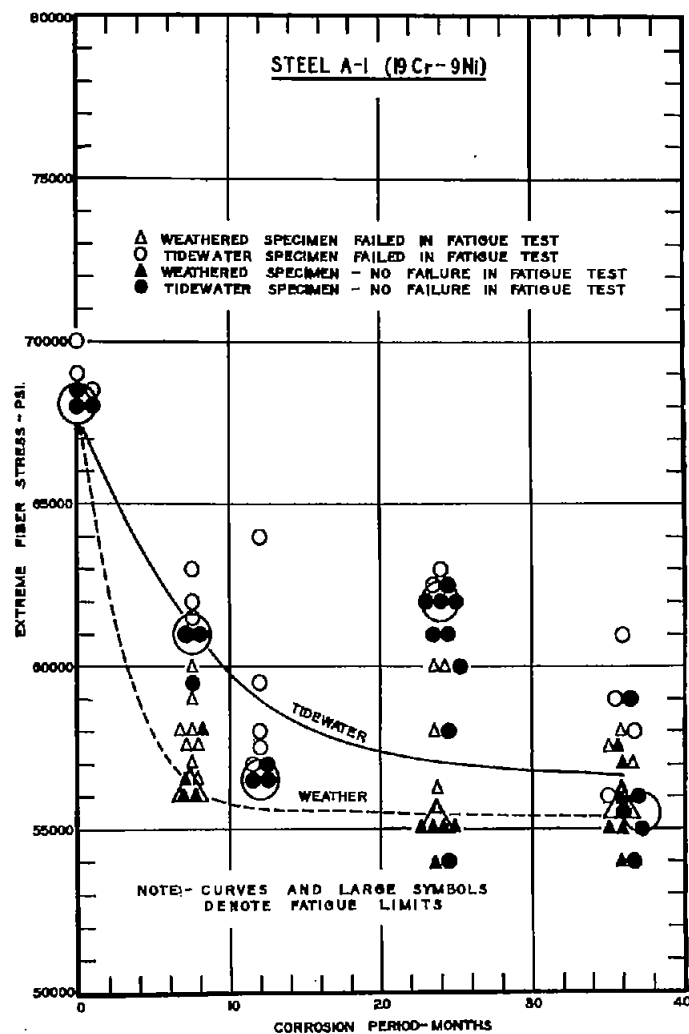
Figure 9.- Results of flexural fatigue tests on Steel A-1, giving the data for each specimen tested (small symbols), and the approximate fatigue limits (large symbols).

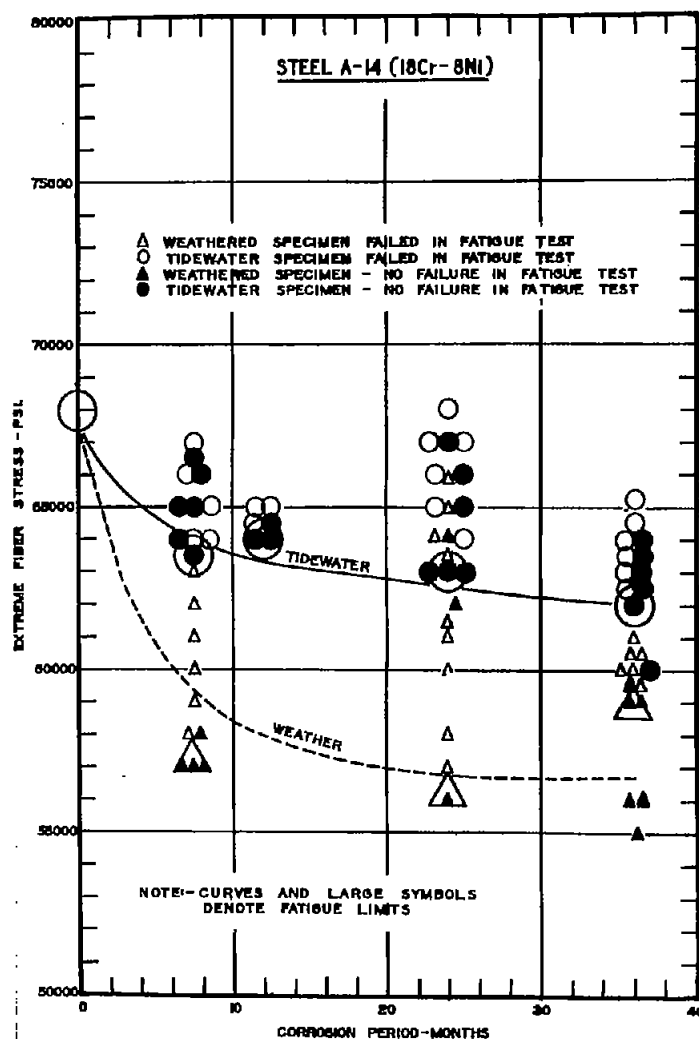
Figure 10.- Results of flexural fatigue tests on Steel A-14, giving the data for each specimen tested, and the approximate fatigue limits.

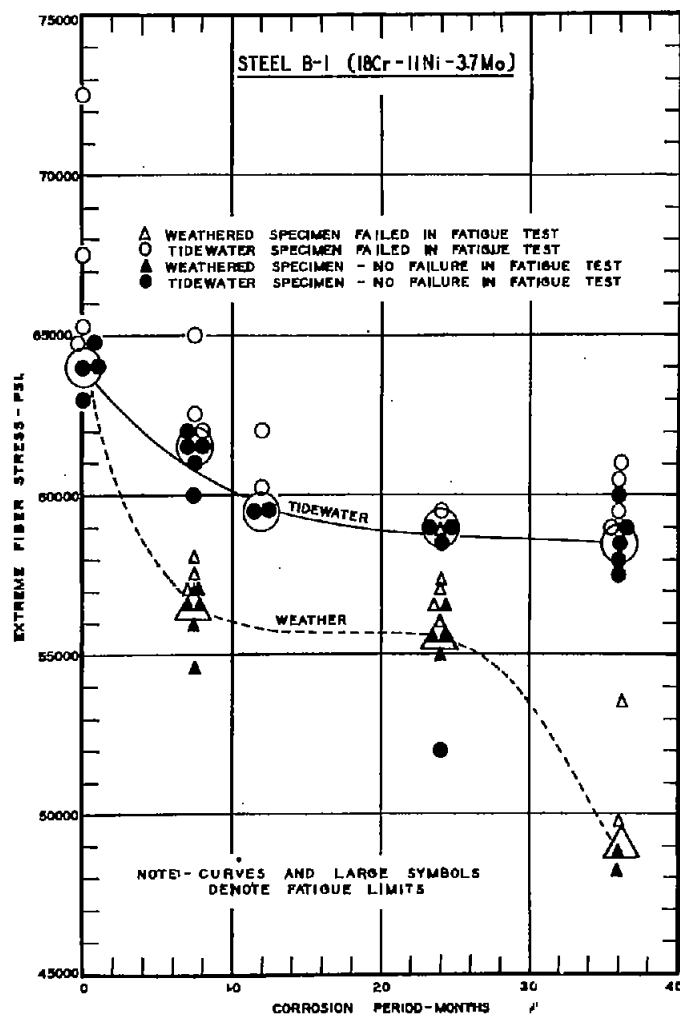
Figure 11.- Results of flexural fatigue tests on Steel B-1, giving the data for each specimen tested, and the approximate fatigue limits.

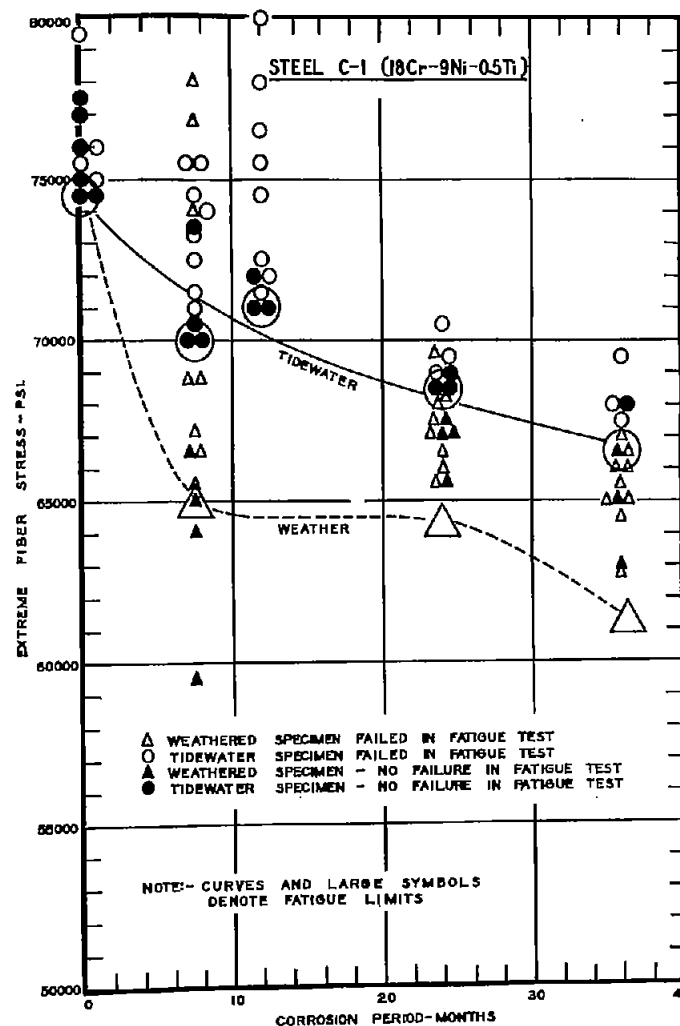
Figure 12.- Results of flexural fatigue tests on Steel C-1, giving the data for each specimen tested, and the approximate fatigue limits.

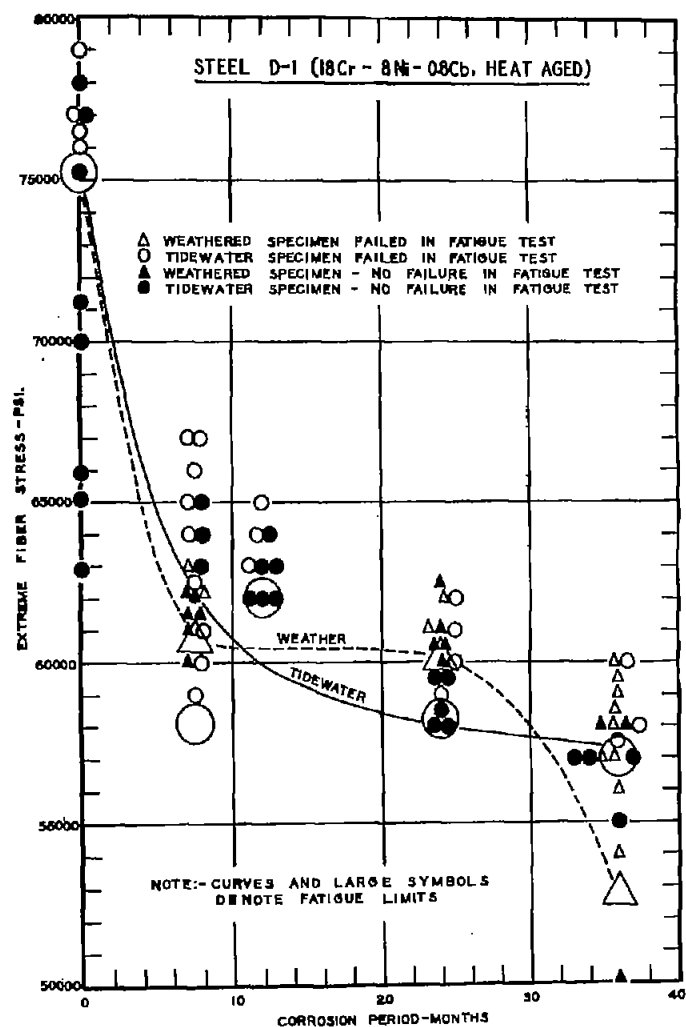
Figure 13.- Results of flexural fatigue tests on Steel D-1, giving the data for each specimen tested, and the approximate fatigue limits.

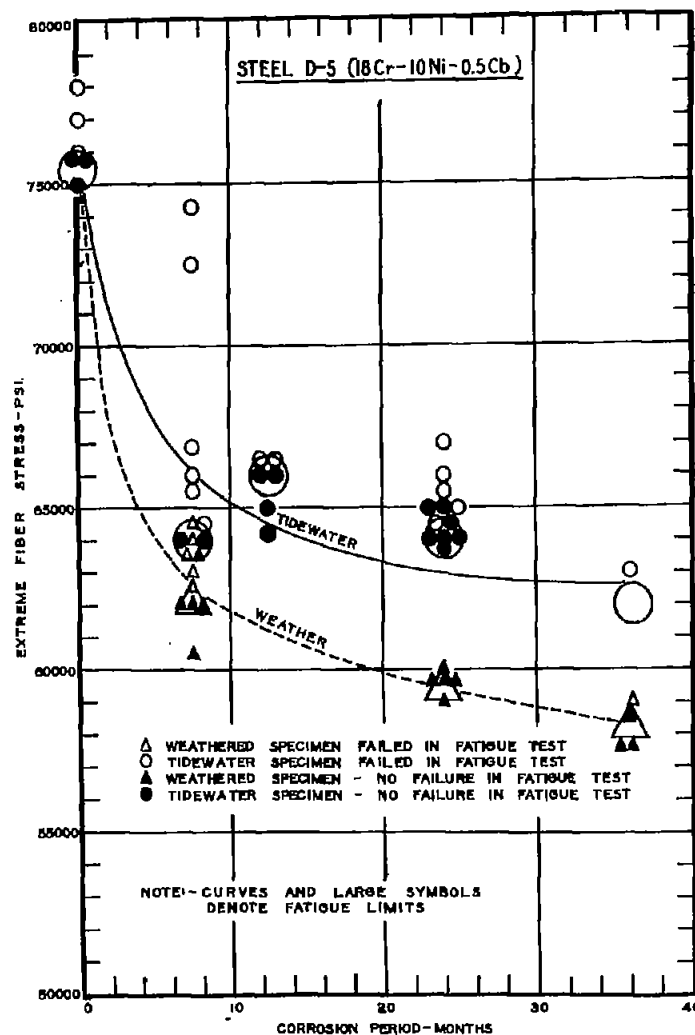
Figure 14.- Results of flexural fatigue tests on Steel D-5, giving the data for each specimen tested, and the approximate fatigue limits.

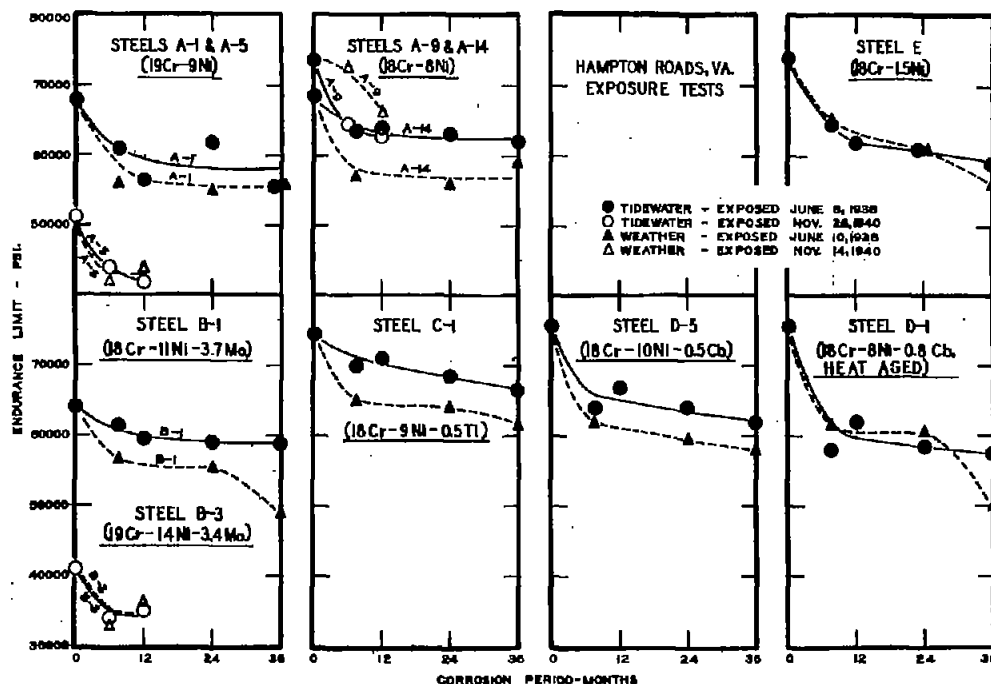
Figure 16.- The charts summarize the data for each of the steels (figs. 9-15, 19-21) exposed at Hampton Roads, Va., and show the loss in fatigue limits as related to the period of exposure. Panels exposed in 1938 were located at Boush Creek, while those exposed in 1940 were located at the Lagoon.

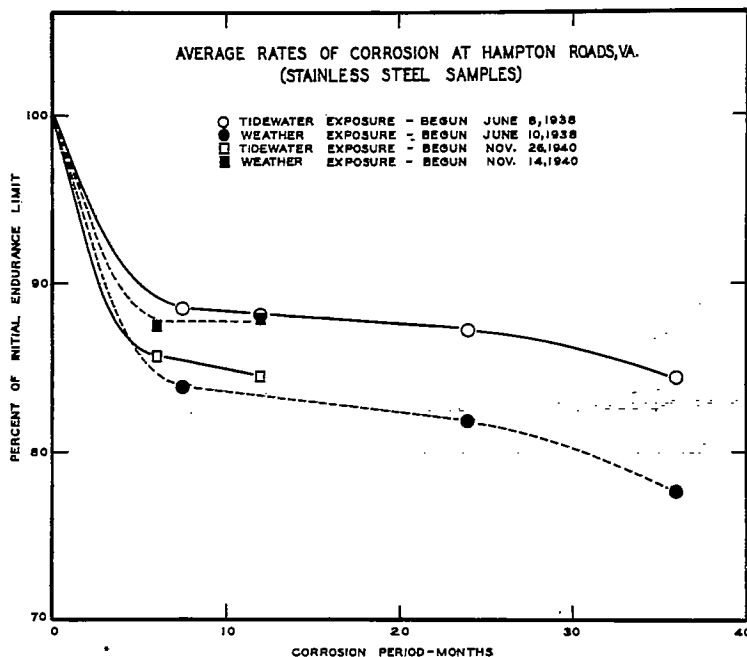
6. The relative susceptibility to corrosion of the particular sheets under the specific conditions of exposure used in these investigations (fig. 17) could be established by fatigue tests. These revealed a superiority in the steels containing molybdenum or titanium, and an inferiority of the heat-aged columbium-bearing steel and one of the 16:1 type. The relatively narrow range of the loss in fatigue limits (± 5 percent) for all the steels except the last two, indicated that the order of susceptibility may be expected to show variations, within the ranges established, on different heats of metal exposed under the same, or other marine conditions.

Figure 17.- Panels exposed in 1938 were located at the Boush Creek site, while those exposed in 1940 were located at the Lagoon, at the U.S. Naval Air Station, Hampton Roads, Va. The data are the average for all the stainless steel panels, irrespective of their chemical compositions.

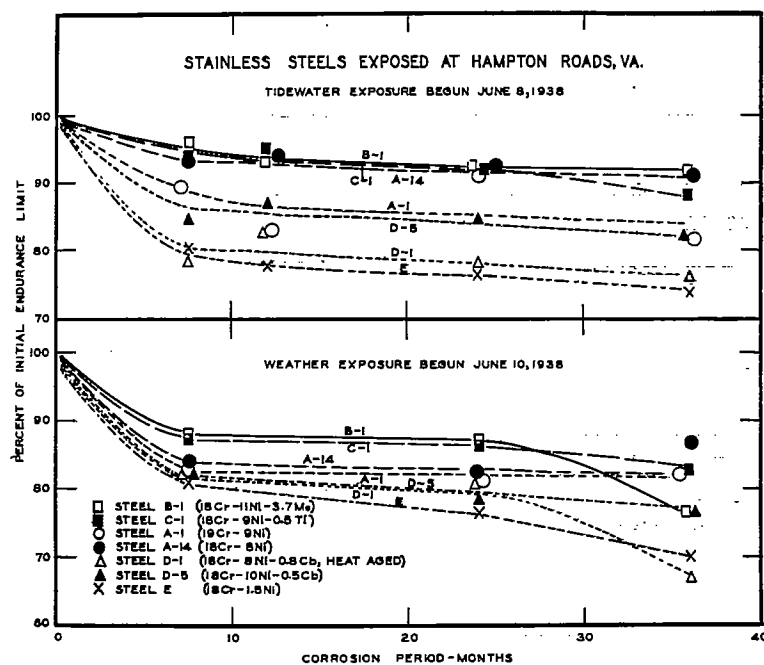
Figure 18.- The comparative rates of corrosion for each steel exposed at the Boush Creek site, Hampton Roads, Va.

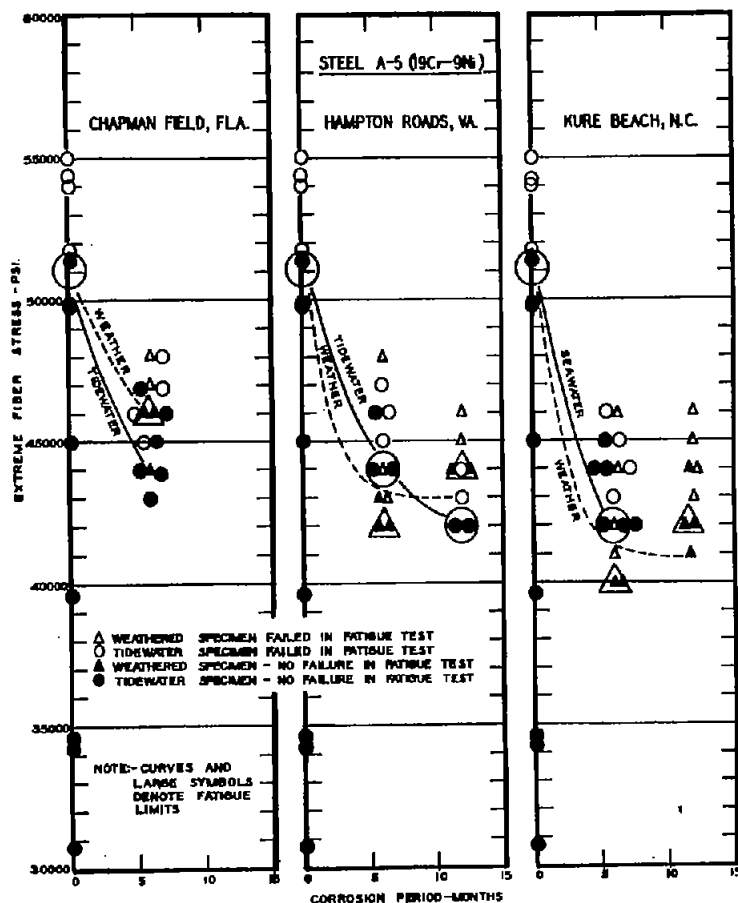
The results of the fatigue tests on panels exposed simultaneously (Steels A-5, A-9, and B-3) at Hampton Roads, Kure Beach, and Chapman Field (figs. 19, 20, 21, and 22) already have been given with respect to the behavior of each steel. The average data for the three steels (fig. 35), plotted on the basis of percent loss of initial endurance limit, reveals more informatively the rates of corrosion as related to

Figure 19.- Results of flexural fatigue tests on Steel A-5 exposed simultaneously at the three localities, giving the data for each specimen tested, and the approximate fatigue limits.

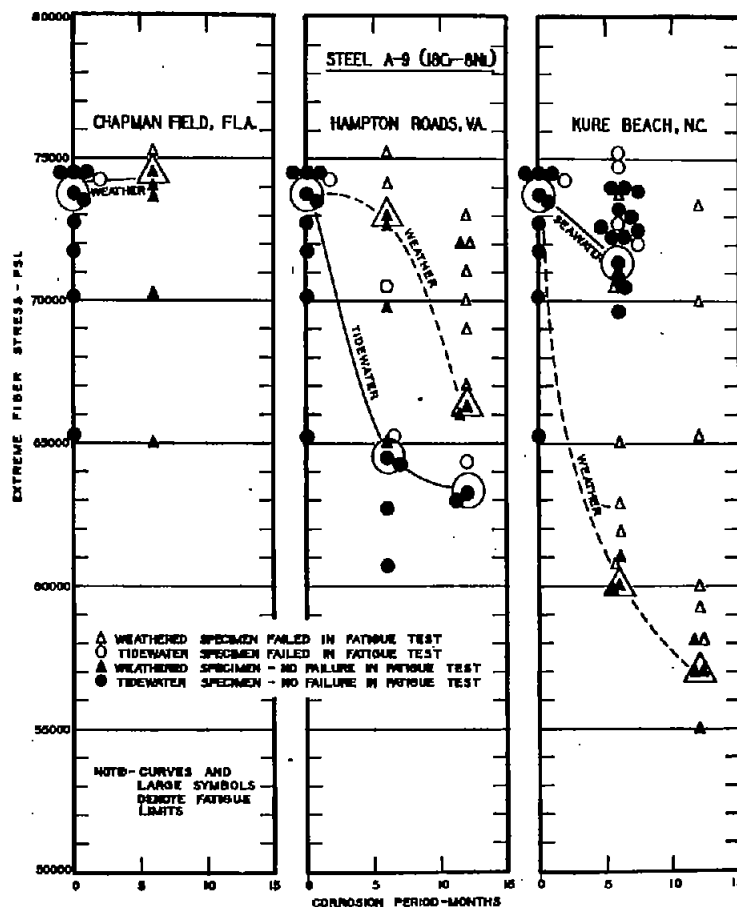
Figure 20.- Results of flexural fatigue tests on Steel A-9 exposed simultaneously at the three localities, giving the data for each specimen tested, and the approximate fatigue limits.

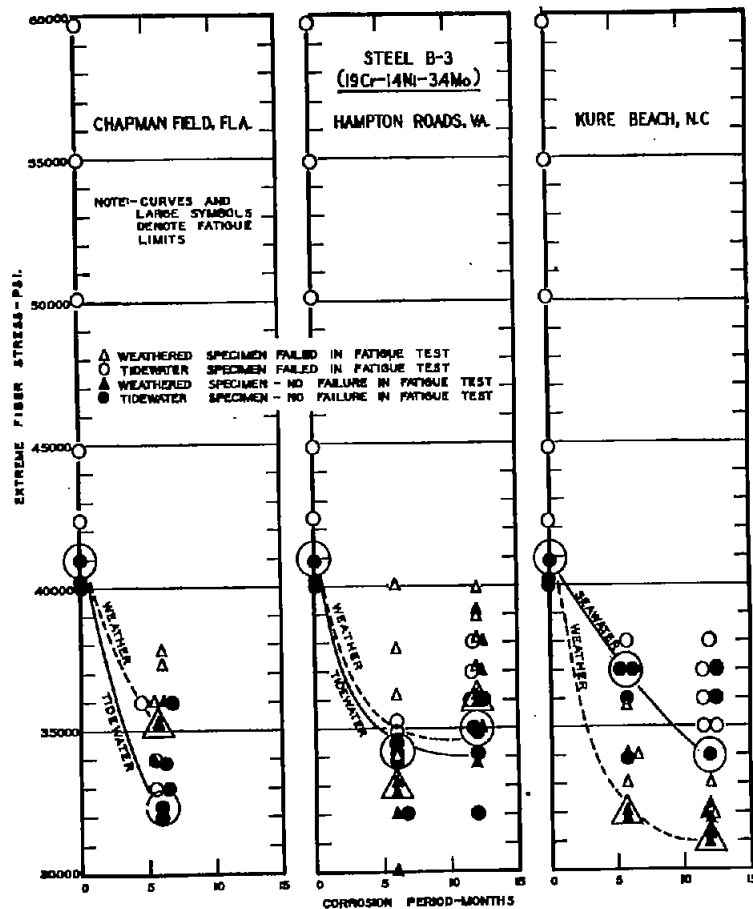
Figure 21.- Results of flexural fatigue tests on Steel B-3 exposed simultaneously at the three localities, giving the data for each specimen tested, and the approximate fatigue limits.

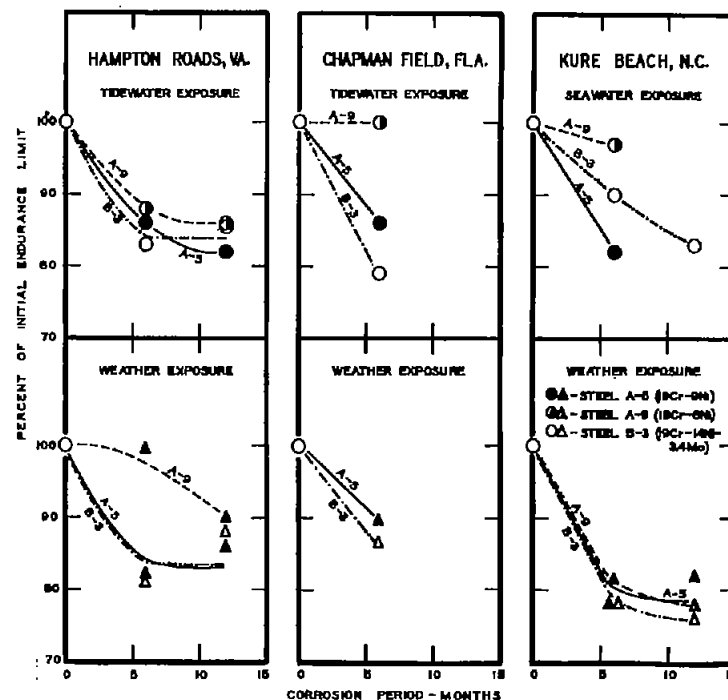
Two straight 18:8 type steels, one (A-9) with a tensile strength of 190,000 psi, and the other (A-5) with 100,000 psi, along with a 1/4-hard-rolled steel (B-3) having a tensile strength of 120,000 psi were exposed simultaneously at the three localities. The fatigue tests (fig. 22) revealed that steel A-9 usually was the least susceptible to corrosion. Steel A-5 was somewhat more resistant to corrosion than steel B-3 under all the conditions of exposure, except in the sea water at Kure Beach, N. C.

Figure 22.- The charts summarize the data for each of the steels exposed simultaneously at the three localities (figs. 19, 20 and 21), and show the loss in fatigue limits as related to the period and type of exposure.

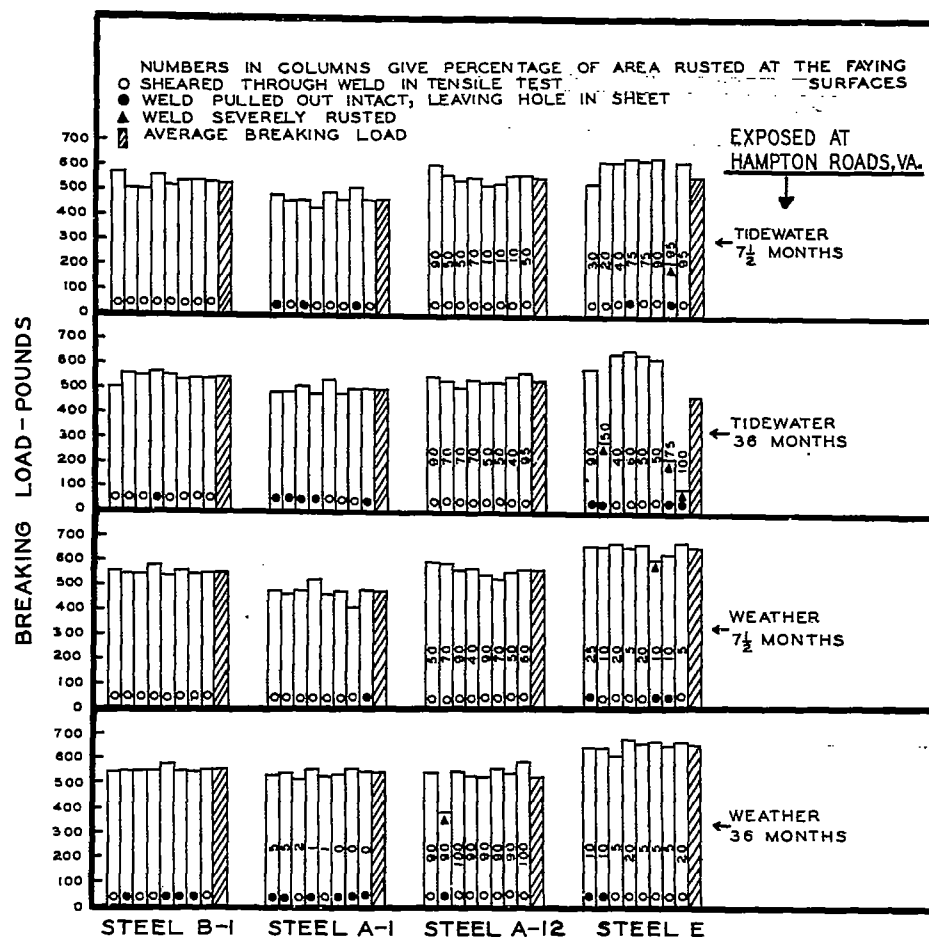
Representative results of the tensile tests on a few of the steels (fig. 24) reveal that, except for isolated instances on corroded welds, the range in breaking loads for the single welds was within narrow limits. The highest values were obtained on steel E. Tests made at the E. G. Budd Manufacturing Company on similar welds in this 16:1 type steel, showed that they would withstand a twist of only 10° before failure; whereas welds in the 18:8 type steels withstood a twist of 90° before failure. Shot welds in alloys corresponding to steel E probably would not prove as satisfactory as the austenitic type alloys for highly stressed structures.

Figure 24.- Results of tensile tests on individual shot-welds from representative panels after exposure at Hampton Roads, Va.

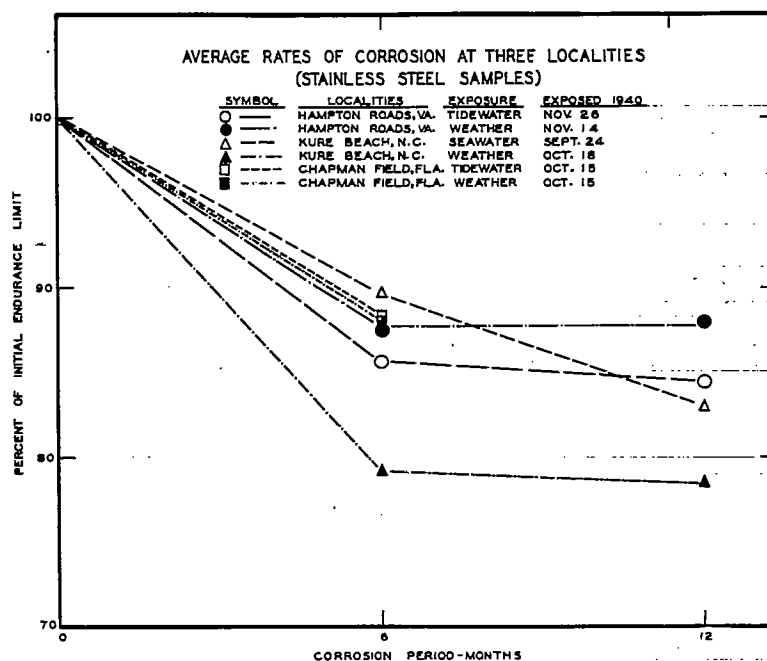
the locality of exposure. Panels exposed to the weather at Kure Beach exhibited more loss in fatigue limits than those exposed under any of the other marine conditions. These curves show that after exposure to weather or tidewater at Hampton Roads or Chapman Field, or after exposure to sea water at Kure Beach, the average variation in the percentage of loss in the fatigue limits was within $\pm 2\frac{1}{2}$ percent. This compares closely with the value of ± 3 percent (fig. 17) obtained at the Hampton Roads station on a larger number of specimens initially exposed on a different date.

Figure 35.- The average percentage of loss of endurance limit of stainless steel panels exposed to the weather or tidewater at Hampton Roads and Chapman Field, or to the sea water at Kure Beach is shown to be very similar, the deviation being less than ± 3 percent. Panels exposed to the weather at Kure Beach were the ones most severely corroded.
